Replacement AHU Cooling Coils

**LOCATION:
Westquay Shopping
Centre, Southampton**

**CLIENT:
Hammerson**

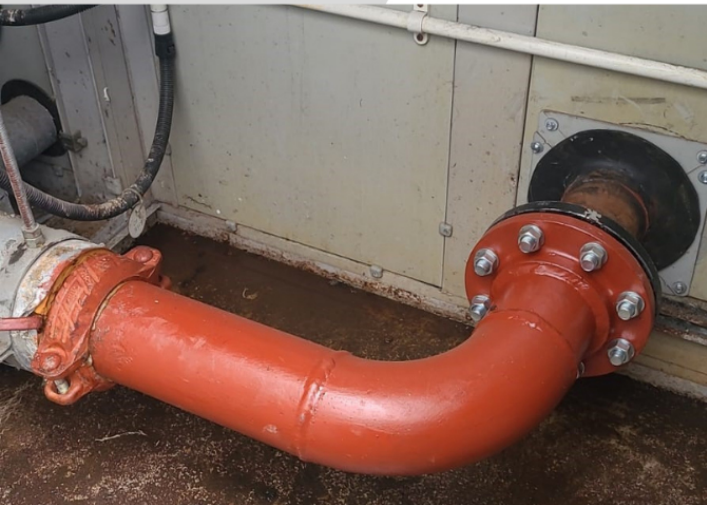
The facilities management team for the centre identified three air handling units that provided cooling to the shopping malls were found to have leaking cooling coils caused by frost damage over the winter period and needed replacing ready for the summer period.

Beatties were employed to carry out the supply and installation of three new air handling cooling coils. Two of the coils were manufactured and delivered to site as complete block coils, ready for installation. One was too large to be manoeuvred on to the roof area and had to be delivered in kit form and be assembled on site, ready for installation.

- Disconnect and drain existing chilled water coils
- Modify pipework to enable coils to be removed and replaced
- Remove existing chilled water coils
- Strip down redundant coils to enable them to be removed from site
- Fit new chilled water coils within AHU 4 & AHU 7 and refit coil access panel
- Assemble kit form coil for AHU 17 and fit within AHU
- Pipework modifications and reconnection of new coils
- Replace lagging
- Pressure testing of coils
